ELVAL COLOUR

Anti-graffiti coating

Graffiti removal advice agraphon® coatings

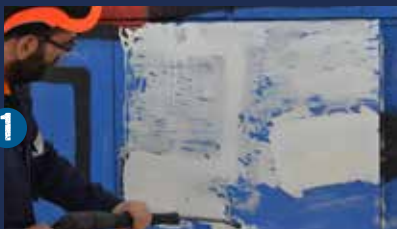
1 Clean the surface with pressurized water (max 50 bar), for dirt removal. Warm water on metal surfaces helps in graffiti removal. The water temperature must not exceed 80°C. In the majority of cases most of the graffiti will be already removed with this step. If not, then follow the next step.

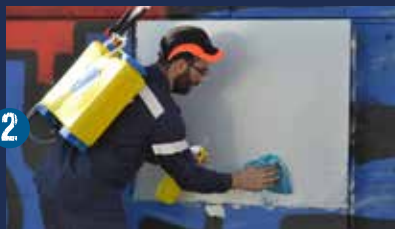
2 Treat the graffiti with a mild alcohol mixture. Use a soft pad and mildly clean the surface. Make sure that the whole surface is treated. The alcohol must not be left on the surface for a long period of time.

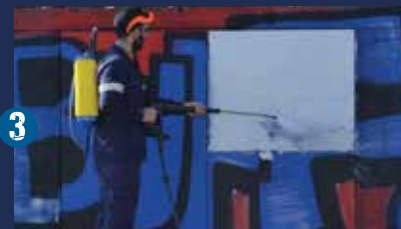
3 Use pressurized water for alcohol and graffiti removal from the facade. If the graffiti is not completely removed steps 1 to 3 must be repeated. The quickly cleaned facade from the graffiti will discourage the graffiti vandals from attacking the building again.
